## Windstorm Mitigation Report

Villa Manor

Punta Gorda, FL

As of 08-14-2025 | FPAT File# MIT2524780

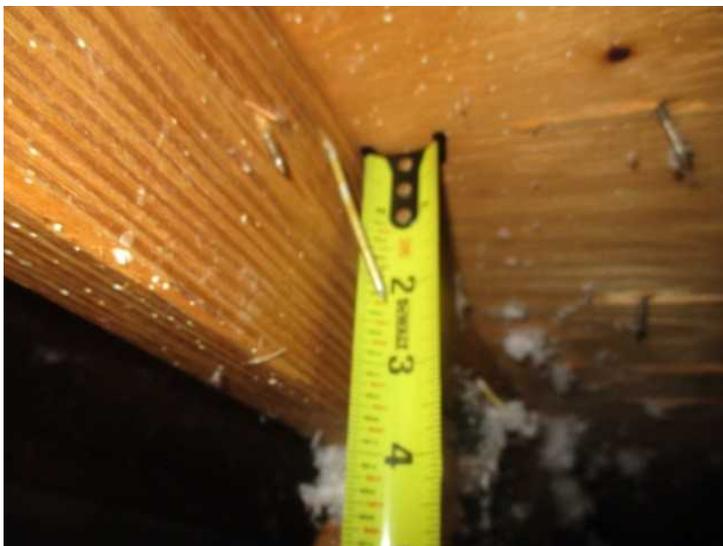
Roof Construction

- 4. Roof to Wall Attachment:** **Clips**  
Comments: Inspection verified embedded straps fastened with a minimum of three nails.
- 5. Roof Geometry:** **Hip Roof**  
Comments: Inspection verified a hip roof shape.

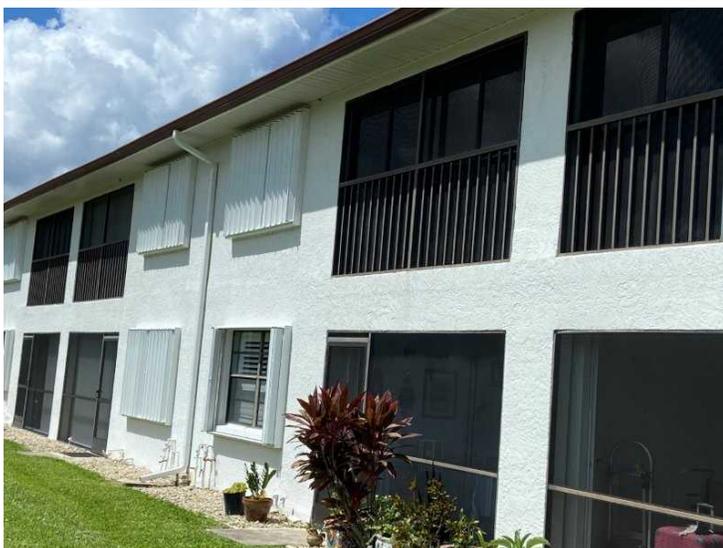
Opening Protection

- 6. SWR:** **Yes**  
Comments: SWR was verified at time of inspection. The Secondary Water Resistance verified is a self-adhering peel and stick.
- 7. Opening Protection:** **Exterior Openings Cyclic Pressure & 9-lb Large Missile**  
Comments: Inspection verified all windows and sliding glass doors are protected with large missile rated corrugated metal or aluminum hurricane panels. See attached photographs and supporting documentation.

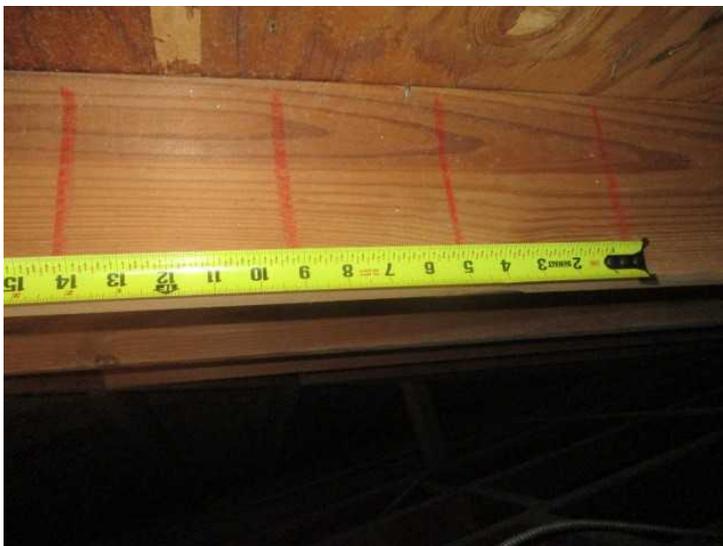
Roof Construction

- 4. Roof to Wall Attachment:** **Clips**  
Comments: Inspection verified embedded straps fastened with a minimum of three nails.
- 5. Roof Geometry:** **Hip Roof**  
Comments: Inspection verified a hip roof shape.

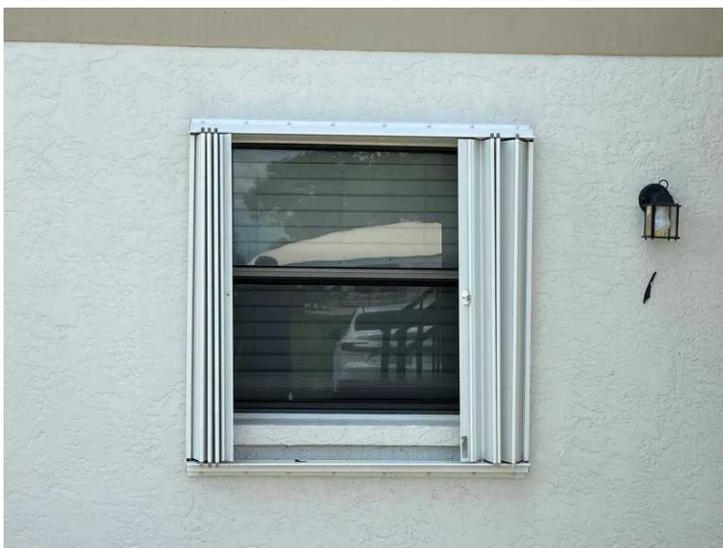
Opening Protection

- 6. SWR:** **Yes**  
Comments: SWR was verified at time of inspection. The Secondary Water Resistance verified is a self-adhering peel and stick.
- 7. Opening Protection:** **Exterior Openings Cyclic Pressure & 9-lb Large Missile**  
Comments: Inspection verified all windows and sliding glass doors are protected with large missile rated corrugated metal or aluminum hurricane panels. See attached photographs and supporting documentation.
